Step/Skirt Performance Index Testing and Data Analysis

How to avoid common problems when measuring this important safety parameter, particularly with the PMT IMD-1 tool

by Ken Smith

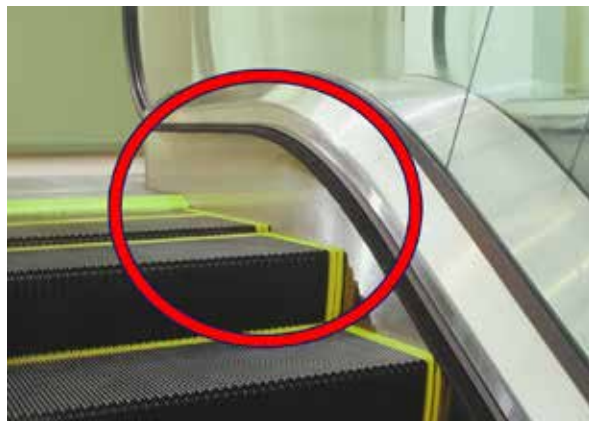
Figure 1

- ◆ Make sure there is no debris on the unit that could interfere with the test.
- ◆ Check the slide or stopping distance so that when the unit is stopped, the IMD-1 will not slide into the combteeth. (Some older escalators have very long slides.)
- ◆ Make sure the height of the skirt deflectors at each end will not contact the tool's sensor. Deflectors with plenty of clearance are shown in Figure 1.

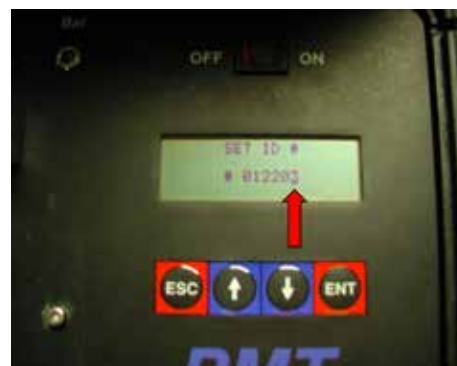
Figure 2

- 2) When stepping through the test menu, "Set ID #" appears. This is where the user enters the unit identifier. When entering the last digit (note arrow in Figure 2) and pressing the "Enter" button, make sure nothing is touching the friction face, as the friction force transducer is being calibrated at this point.

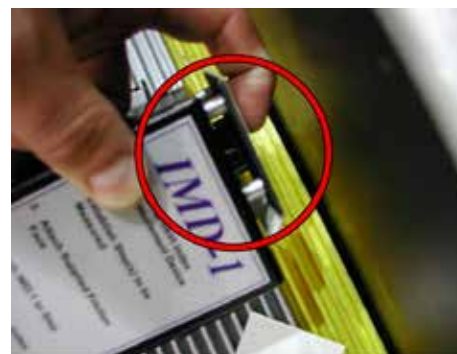
Figure 3

- 3) When "Set Distance to Zero" appears, the friction shoe must be pushed toward the sensor housing until *all four* silver studs contact the housing (Figure 3). Hold in this position and press the "Enter" button. At this point, the position (loaded gap) transducer is calibrated. If the user is not careful, the sensor will calibrate incorrectly, generating invalid loaded-gap measurements (sometimes negative), which will result in inaccurate index results. This step is sometimes difficult due to lighting, unit width and the location of the skirt deflectors.

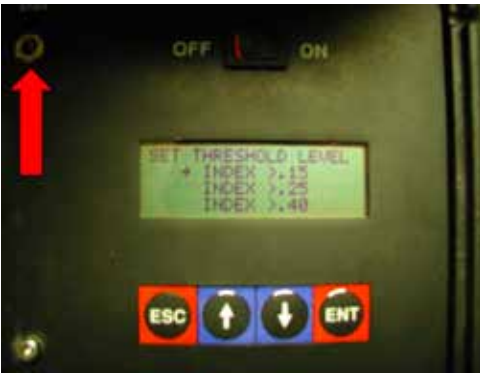
Real Time Mode can be used to find problems with steps, the track and skirts. It is useful to use this mode for testing the loaded gap at each end of the unit, as well. (Interestingly, your author has never seen the loaded gap measurements at each end of the unit turned in to the AHJ.) Select "Real Time Mode" from the menu. From the "Set Threshold Level" menu, select the index desired to be the maximum, and set up the tool as previously described. If or when the index exceeds the set threshold, the red LED pointed to in Figure 5 will light, identifying the location of a problem on the unit.

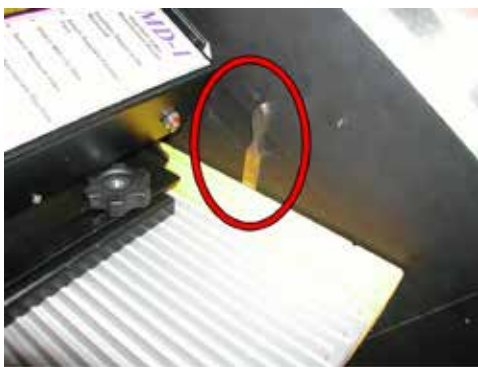
The loaded gap can be verified with a blade gage if there is a question of tool setup. Just place the gage between the step and skirt as shown in Figure 6 when the IMD-1's spring is compressed. The blade gage should read a loaded gap very close to the one the tool reads. Using the blade gage in this manner is useful if the index test shows an unusually small loaded gap on an older escalator.

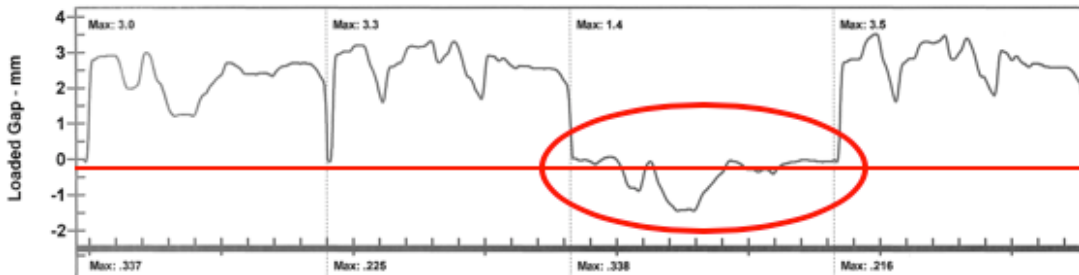
Figure 9

Loaded gap negative on Step 2 Right test
 (did not zero polycarbonate friction shoe for that test)

Many index tests with negative loaded gaps (Figure 9) have been accepted by AHJs. A negative loaded gap indicates improper tool setup. Typically, the cause is that the friction face is not pressed in

completely during “set distance to zero.” Note that an index test with a negative loaded gap is invalid, and the unit will need to be retested.

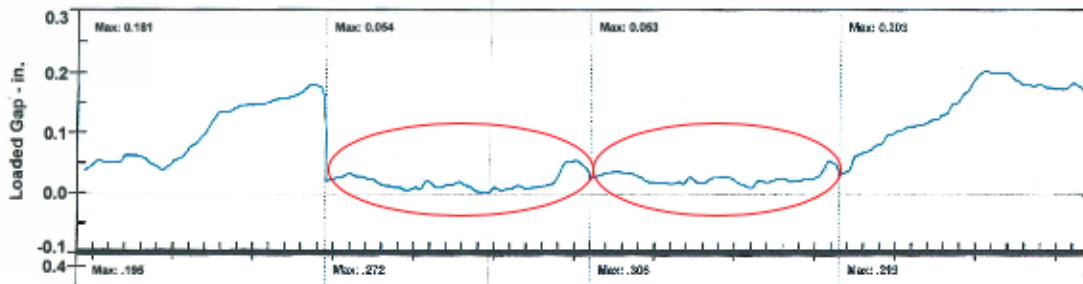
Figure 11

Mixed up left and right sides of steps

In Figure 11, left and right were mixed up during the test: the sides of one of the steps tested was entered as the right, when it was actually the left, and the same occurred with the other side. Interestingly, the circled loaded gaps on one side are almost zero, indicating improper tool setup (or steps that contact the skirt for most of the incline). Your author would want the escalator retested.
